**05-008/14 - MULTI-MODEL (6 SPEED SKYACTIV M/T) - HARD
TO SHIFT INTO 3RD, 4TH, 5TH AND/OR 6TH GEAR**

Service Bulletin

- This bulletin supersedes the previous bulletins 05-008/14 issued on 07/14/14. The APPLICABLE MODELS, DESCRIPTION, REPAIR PROCEDURE, and WARRANTY INFORMATION have been revised.
- Changes are noted below beside the change bar in Red.

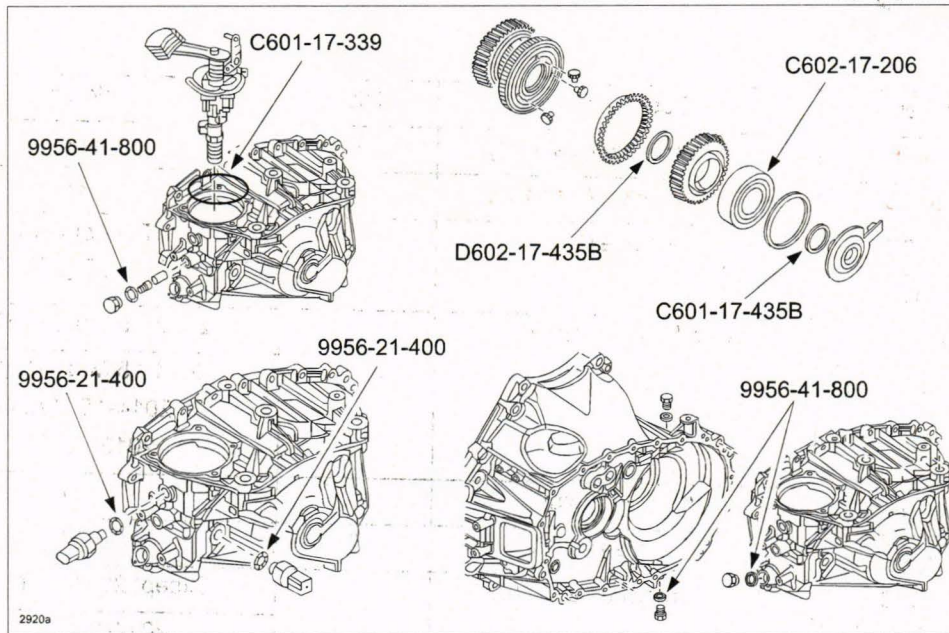
Part Number	Description	Qty.	Notes
C602-17-240B	3-4 Clutch Hub Assembly	1	All
C602-17-620B	5-6 Clutch Hub Assembly	1	All
C601-17-230B	3rd Gear**	1	Except CX-5
C610-17-230A			CX-5
G054-25-421	Clip for drive shaft*	1	2012-15 Mazda3 (2.0L)
H010-25-421A			2014-15 Mazda3 (2.5L) 2014-15 Mazda6 2013-15 CX-5
D651-33-042A	Wheel Hub Nut*	2	All
T060-26-169A	Clip for Tie-rod End*	2	All
B455-32-099B	Bolt for Intermediate Shaft*	1	Except 2014-15 Mazda3
KD31-32-099			2014-15 Mazda3
D602-17-435B	Retaining Rig*	1	All
C601-17-435B	Retaining Rig*	1	All
C602-17-206	Ball Bearing*	1	All
C601-17-339	"O" Ring*	1	All
9956-41-800	Washer*	2	All
9956-21-600	Gasket*	1	All
9956-21-400	Washer*	2	All
0000-77-5W80-QT	Manual Transaxle Oil	3	Specification: 2.6 - 2.7 US qt

* Replacement parts

** Replace 3rd gear only if necessary (if 3rd gear jumps out).
